DEPARTMENT OF TRANSPORTATION**DIVISION OF ENGINEERING SERVICES**

Office of Structural Materials

Contract #: 04-0120F4Cty: SF/ALA Rte: 80 PM: 13.2/13.9File #: 69.28**WELDING INSPECTION REPORT****Resident Engineer:** Pursell, Gary**Address:** 333 Burma Road**City:** Oakland, CA 94607**Report No:** WIR-003099**Date Inspected:** 24-Jun-2008**Project Name:** SAS Superstructure**OSM Arrival Time:** 1430**Prime Contractor:** American Bridge/Fluor Enterprises, a JV**OSM Departure Time:** 2230**Contractor:** Zhenhua Port Machinery Company, Ltd (ZPMC), Changxing Island **Location:** Shanghai, China**CWI Name:** Li Yan Hua**CWI Present:** Yes No**Inspected CWI report:** Yes No N/A**Rod Oven in Use:** Yes No N/A**Electrode to specification:** Yes No N/A**Weld Procedures Followed:** Yes No N/A**Qualified Welders:** Yes No N/A**Verified Joint Fit-up:** Yes No N/A**Approved Drawings:** Yes No N/A**Approved WPS:** Yes No N/A**Delayed / Cancelled:** Yes No N/A**Bridge No:** 34-0006**Component:** OBG**Summary of Items Observed:**

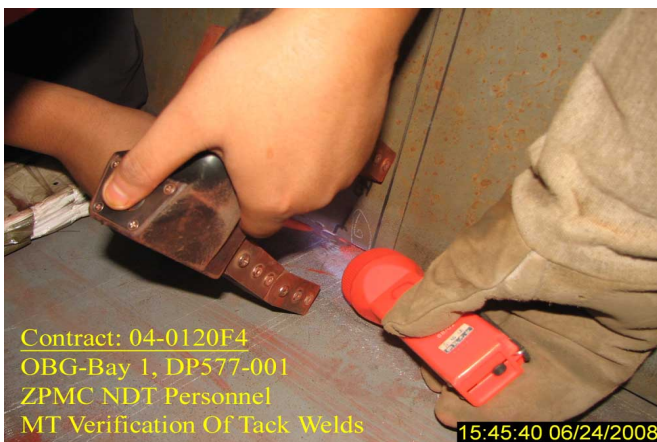
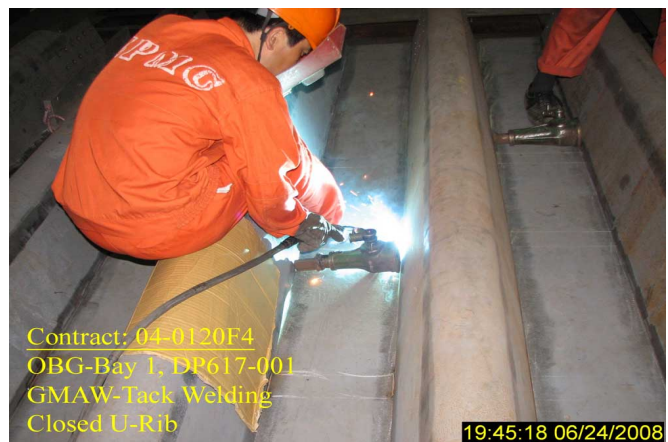
The QA Inspector performed final MT verification after repairs on DP030-001. The MT was performed for approximately 10% of the areas that was previously MT verified by ZPMC NDT personnel. Upon completion of the MT, the QA Inspector signed off the yellow repair tracking tag located on the outside of the closed rib. No relevant indications were observed at the time of testing. Refer to MT report TL-6027, dated 6/24/08 for specific details.
